# Release Notes for iCube Control Products

Release 2025.6

Date: 2026-05-04

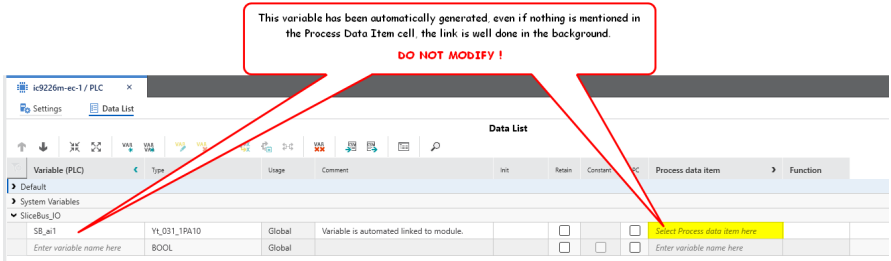
| 49241 | Automatic IO Variable generation : PDIs links to PLC variables are not displayed in the data list | <p>The automatically generated variable may not have a Process Data Item linked to it. The link is made automatically by iCube Engineer automatically in the background. If the user map a PDI, this will overwrite this automatic link done by iCube Engineer.</p> |

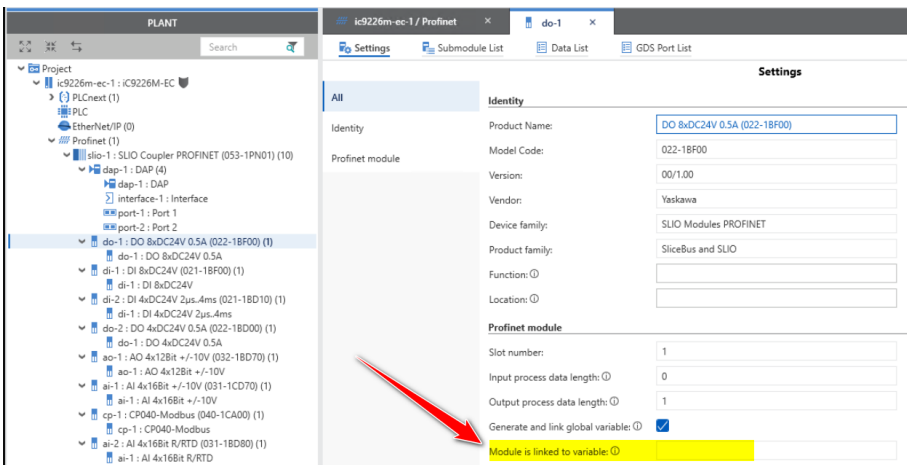
| 56985 | Profinet device integrated via "Online-Devices" has no name for automatically integrated variables | <p>Using the "Online-Device" option to scan Profinet coupler with SLIO module and then use the button "Add to project" create a module with the "Generate link global variable" checkbox checked but no variable linked to it :</p> |

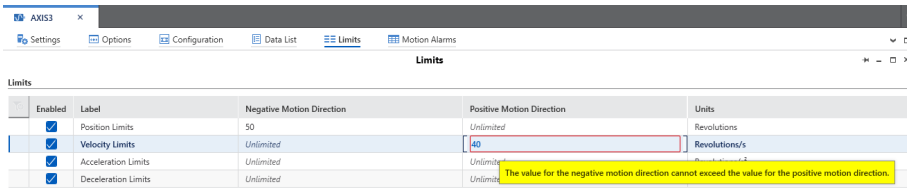
| 57944 | Motion Axes: ServoNet positive Velocity limits is compared to the wrong value | <p>When using motion axes, if the values to be used for velocity, acceleration, and deceleration limits in the positive motion direction are lower than the position limit in the negative motion direction, the software will not allow the setting of said value (see reference image)</p> |

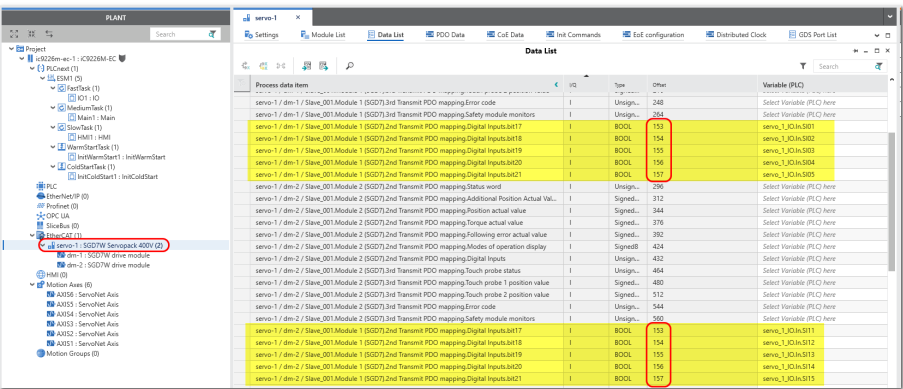
| 60264 | Offset of EtherCAT slave process datum not updated | <p>Some module devices have wrong Offset information display, for example Sigma7W:</p> |

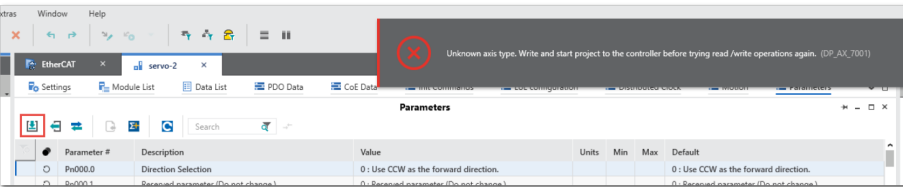
| 60362 | "Unknown axis type" error message when writing parameters to Servopack if faulty network address | <p>The message "Unknown axis type. Write and start project to the controller before trying read /write operations again." will show up if the user tries to Read or Write from/to a SERVOPACK while there is a network identification issue:</p> |

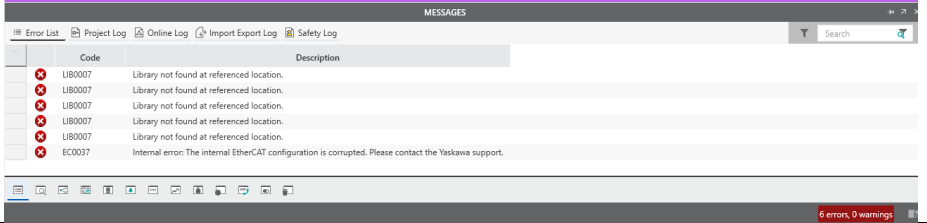
| 65133 | The path of directory does not update in the iCube when installed by choosing a different destination for user data | <p>If the default installation path has been changed during the installation process, the user will experience the following error when creating a project from template:</p> <p>The screenshot shows a 'MESSAGES' window with a table of errors. The table has two columns: 'Code' and 'Description'. There are six error entries, five with code 'LI80007' and one with code 'EC0037'. The descriptions for 'LI80007' are 'Library not found at referenced location.' and for 'EC0037' is 'Internal error: The internal EtherCAT configuration is corrupted. Please contact the Yaskawa support.' The status bar at the bottom indicates '6 errors, 0 warnings'.</p> |

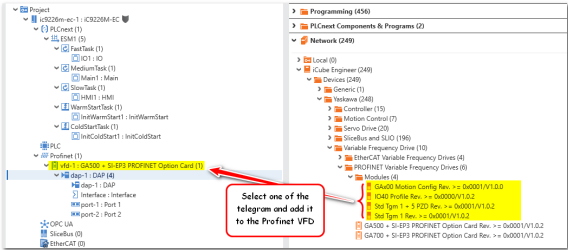
| 43636 | Drive scanned from the Profinet network doesn't add the GAX00 Motion Config module | Executing a Profinet scan functionality on Yaskawa Profinet VFD doesn't add the Profinet telegram Part. | <p>there are 2 solutions:</p> <ul style="list-style-type: none"><li>• add the Profinet VFD from the catalog manually instead of automatically with the Profinet scan</li><li>• add manually Profinet telegram to the Profinet VFD after the scan has been executed:</li></ul> |

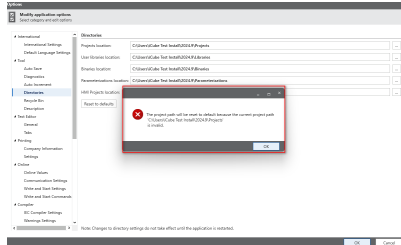
| 65179 | iCube Engineer Crash: when iCube Engineer folders (library, EtherCAT ...) are defined in a location that require Administrator rights | <p>If a directory path that requires Administrator rights is selected during iCube Engineer installation, and the current user does not have Administrator rights, then while updating the paths using Options-&gt;Extra, the following dialog will display and then iCube Engineer will crash.</p> | During iCube Engineer installation and directory selection in Options->Extra, only choose a directory path with full access permissions for the logged in user. |

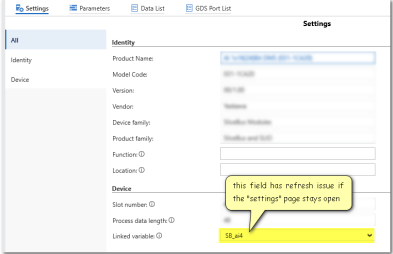
| 66544 | No refresh of dynamic combobox in settings editor | <p>After modifying the name of variable linked to a device in the "settings" page (either by changing the "function/location name and refactoring or just changing the variable name in the PLC table), the combo box in the setting page is not updated automatically.</p> | <p>This is an update/refresh issue of the settings page. To solve this issue leave the Settings page of the device and come back again. Now the display of the linked variable should be corrected.</p> |

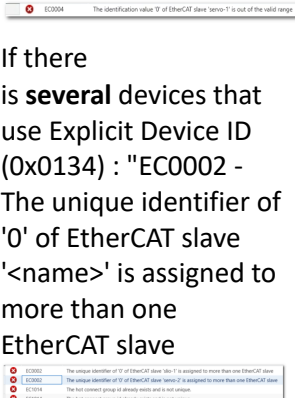
| 67564 | EtherCAT Bus Scan Does Not Properly Populate Identification Value and HC ID | <p>In iCube Engineer 2025.6, the EtherCAT bus scan will automatically recognize the identification value for devices that have the default identification "Station Alias (0x0012)" (e.g. Sigma7 servopacks) BUT will <b>not</b> recognize the identification value for devices that have the default identification "Explicit Device ID (0x0134)" (e.g. SigmaX servopack or EtherCAT bus coupler 053-1EC01), this will fill the identification value 0 and generate the following compilation error :</p> <ul style="list-style-type: none"> <li>• If there is <b>only one</b> device that use Explicit Device ID (0x0134) : "EC0004 - The identification value '0' of EtherCAT slave 'name' is out of the valid range"</li> <li>• If there is <b>several</b> devices that use Explicit Device ID (0x0134) : "EC0002 - The unique identifier of '0' of EtherCAT slave 'name' is assigned to more than one EtherCAT slave"</li> </ul> | Enter manually the correct identification value of the devices with the compile error. |
